Manhole Inspection Summary

Manhole # S21CC_050MH

Insp Date: **9/7/07 9:59 AM**

Location Address: **1700 RIGGS AVE**

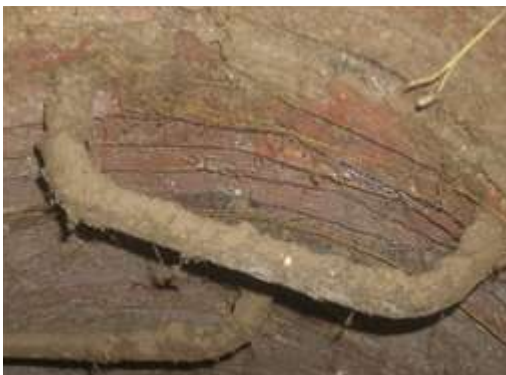
Defect 1

Condition: ☐ Sound ☐ Cracked ☒ **Root Intrusion** ☐ Loose Brick ☐ Deteriorated

ROOT INTRUSION

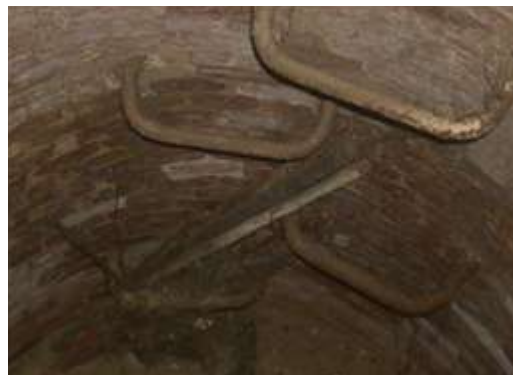
Defect 3

CORRODED STEPS

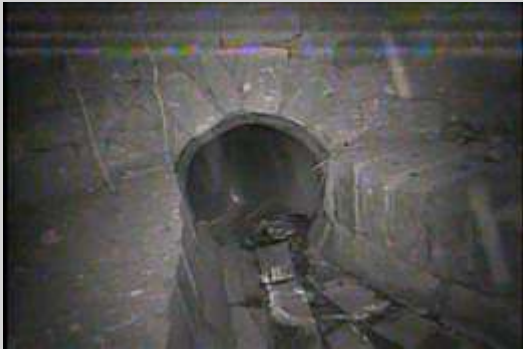
12 O'Clock Outflow

Pipe Height: **8.4** (in.) Rod and Bar (Angled)
Pipe Material: **Clay** ☐ Pipe Lined
Invert Depth: **9.38** (ft.) Flow Characteristics: **Slow**
Deposits: ☒ None ☐ Mud ☐ Sludge ☐ Debris ☐ Grease
Silt Depth: (in.) Deposits Extent:
Infiltration: **None** Pipe Seal Cond: **Sound**

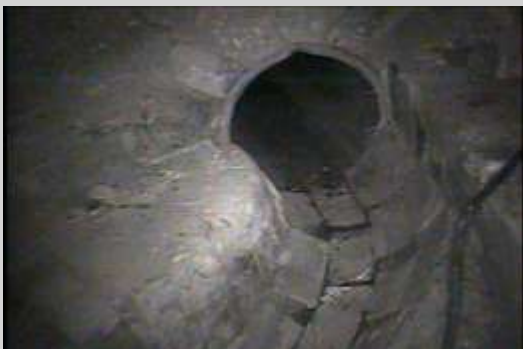
3 O'Clock Inflow

Pipe Height: **8.4** (in.) Rod and Bar (Angled)
Pipe Material: **Clay** ☐ Pipe Lined
Invert Depth: **9.15** (ft.) Flow Characteristics: **Slow**
Deposits: ☒ None ☐ Mud ☐ Sludge ☐ Debris ☐ Grease
Silt Depth: (in.) Deposits Extent:
Infiltration: **None** Pipe Seal Cond: **Broken**
